# **INDOOR AIR QUALITY ASSESSMENT**

**Department of Revenue  
67 Millbrook Street  
Worcester, MA**

Prepared by:  
Massachusetts Department of Public Health  
Bureau of Environmental Health  
Indoor Air Quality Program  
December 2016

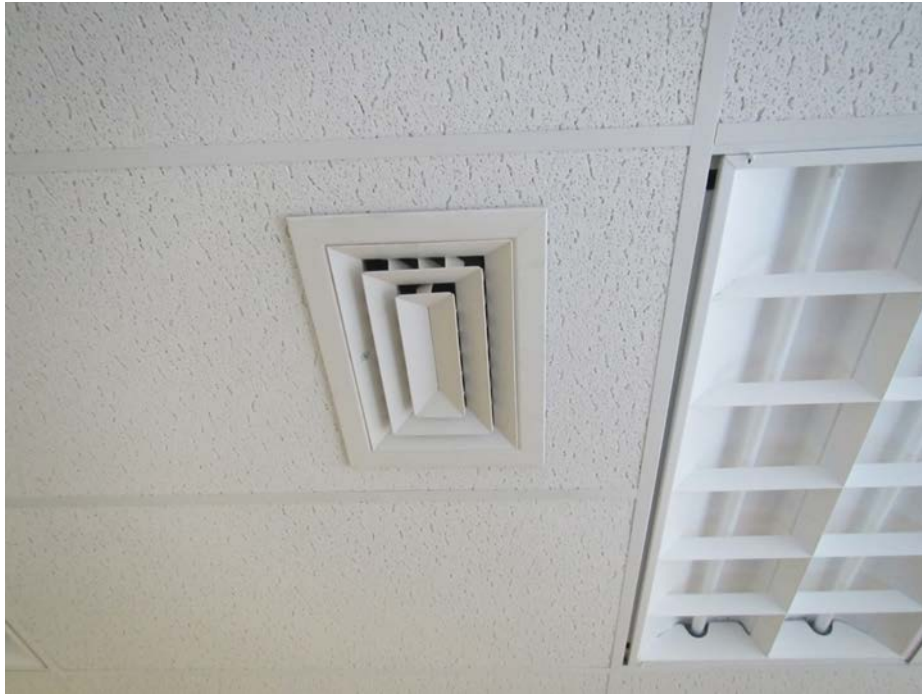
**Picture 1**

Fresh air is provided by air handling units (AHUs). Air from the AHUs is filtered, heated/cooled, and delivered to rooms via ducted supply vents (Picture 1). Air is returned/exhausted through vents in the walls or ceiling (Pictures 2 and 3).

**Supply vent**

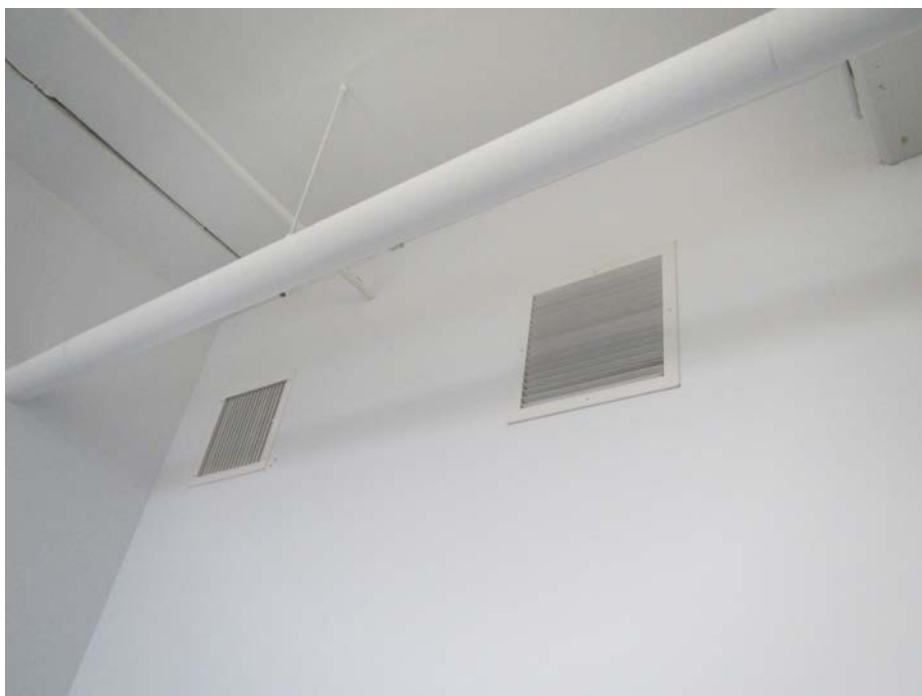
**Picture 2**

**Wall-mounted exhaust vents in Local Services suite**

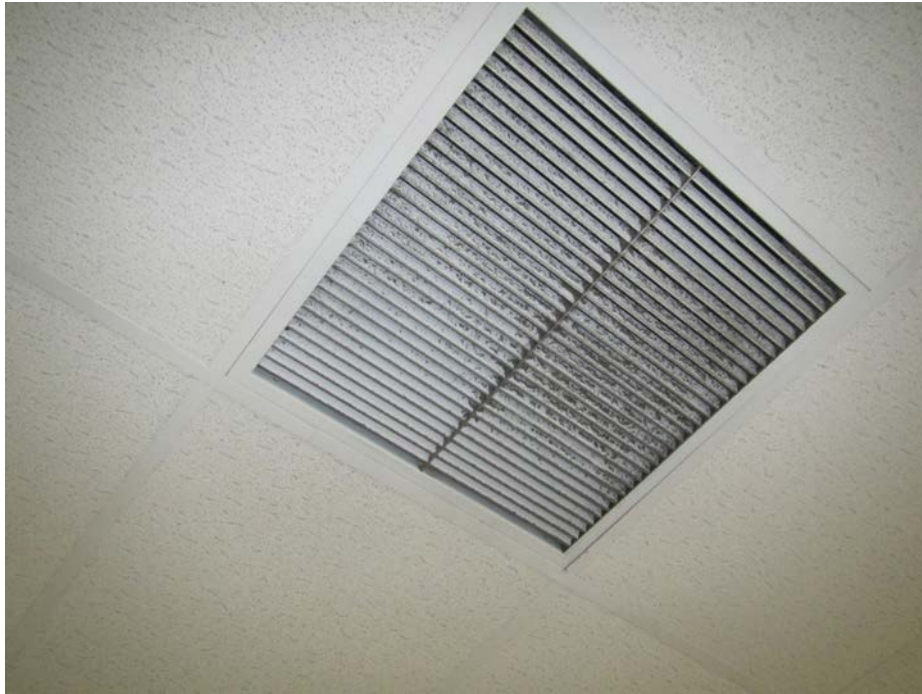
**Picture 3**

Personal fans were observed in a number of areas. Fan blades to some of these units had settled dust, which can be reaerosolized when the fan is activated. Some supply and exhaust vents were also dusty (e.g., Picture 3). It was reported that cleaning of carpeting and vents was scheduled for shortly after this visit.

**Ceiling-mounted exhaust vent in Child Support suite, note dust**

15. Clean the blades of personal fans, supply, and exhaust vents periodically to avoid aerosolizing dusts.
16. Refer to resource manual and other related IAQ documents located on the MDPH's website for further building-wide evaluations and advice on maintaining public buildings. These documents are available at: <http://mass.gov/dph/iaq>.

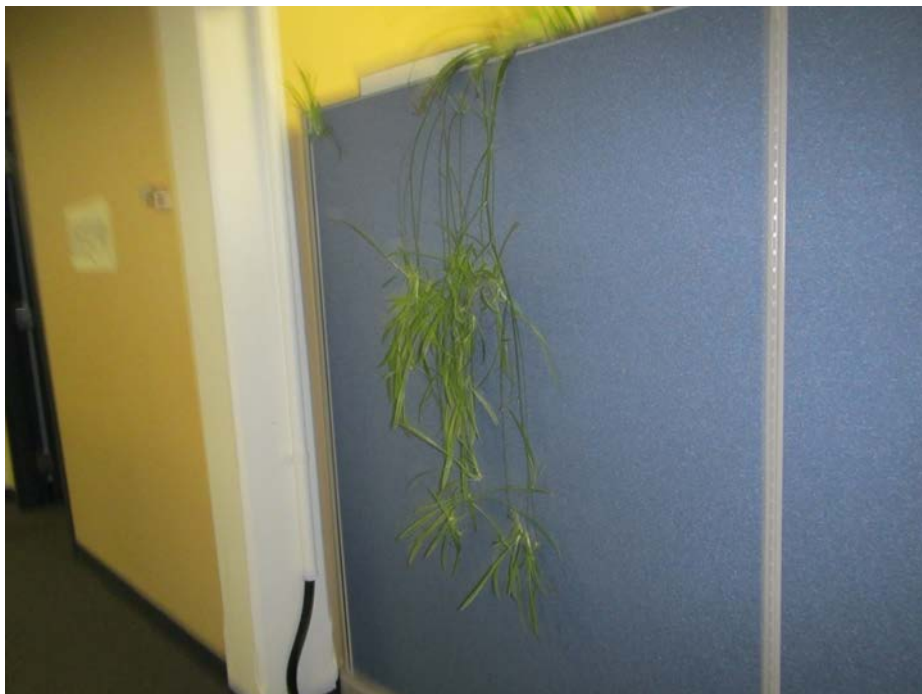
**Picture 4**

Plants were observed in office areas (Table 1; Pictures 4 and 5). Plants can be a source of pollen and mold, which can be respiratory irritants to some individuals. Plants should be properly maintained and equipped with drip pans to prevent water damage to porous materials. Plants should also be located away from air diffusers to prevent the aerosolization of dirt, pollen, and mold.

**Plant overhanging cloth divider**

5. Keep indoor plants in good condition, avoid overwatering, and avoid placing them on porous items such as carpets or paper. Also, keep plants out of the air stream of supply vents.

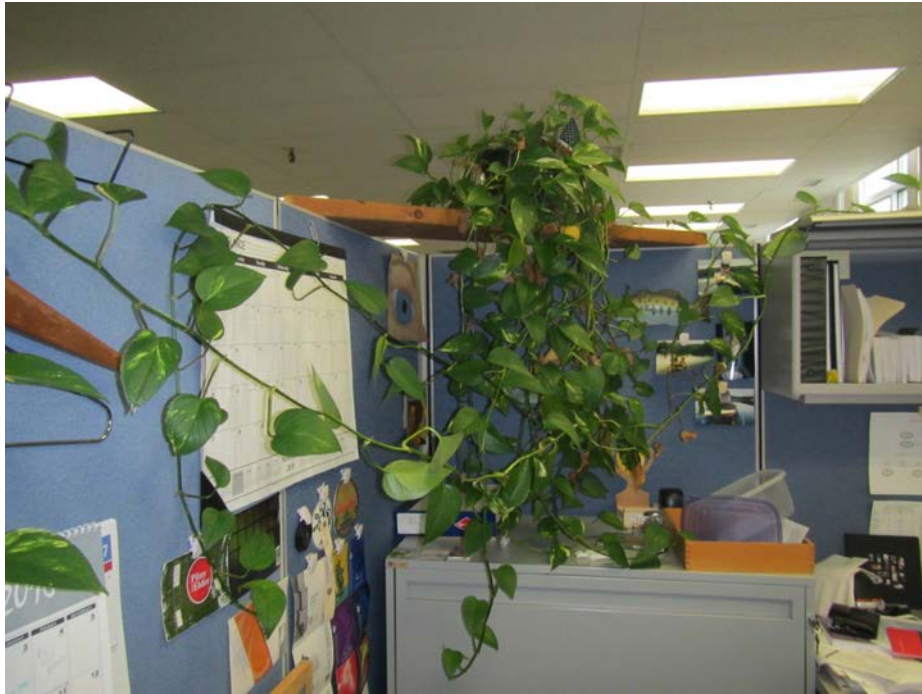
**Picture 5**

**Plants in a cubicle**

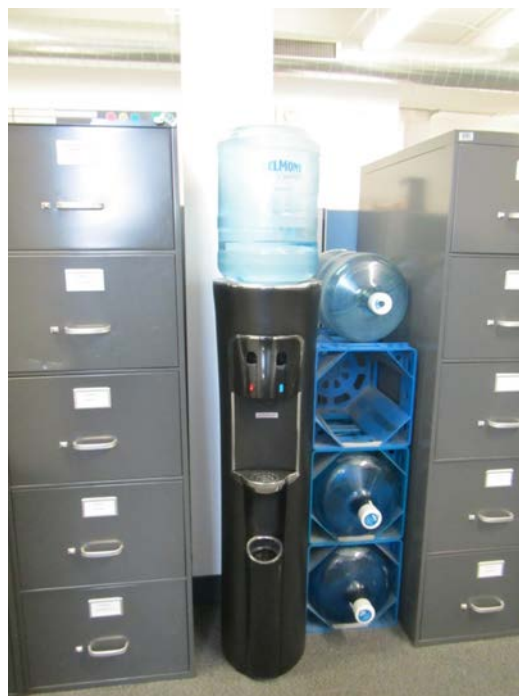
**Picture 6**

Small refrigerators and water dispensers were observed in carpeted areas (Pictures 6 and 7). These appliances may spill or leak and lead to carpet damage and microbial growth; Picture 7 shows stained carpeting next to a refrigerator. It is recommended that these appliances be located in areas without carpeting or on waterproof mats. Carpet squares could also be replaced with tile in areas where water dispensers and refrigerators are located. Some of the refrigerators were crowded with items or had evidence of spills (Picture 8). Refrigerators should be kept clean to prevent odors and microbial growth.

**Water dispenser on carpet**

6. Consider locating refrigerators and water dispensers in non-carpeted areas or place on a waterproof mat.
7. Clean refrigerator spills promptly and clean refrigerators out regularly to avoid odors and microbial growth.

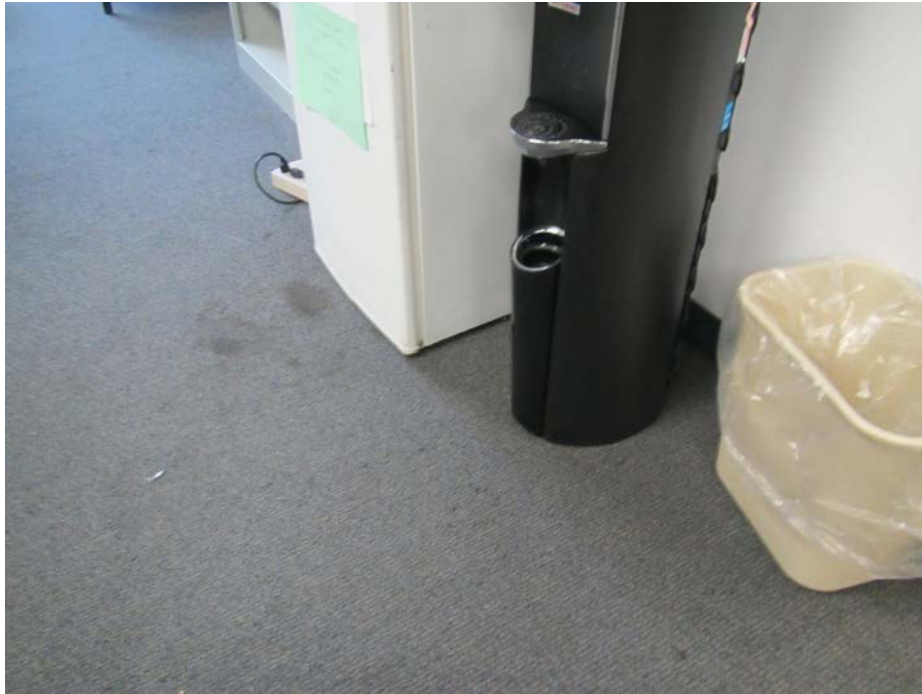
**Picture 7**

**Refrigerator and water dispenser next to stained carpeting**

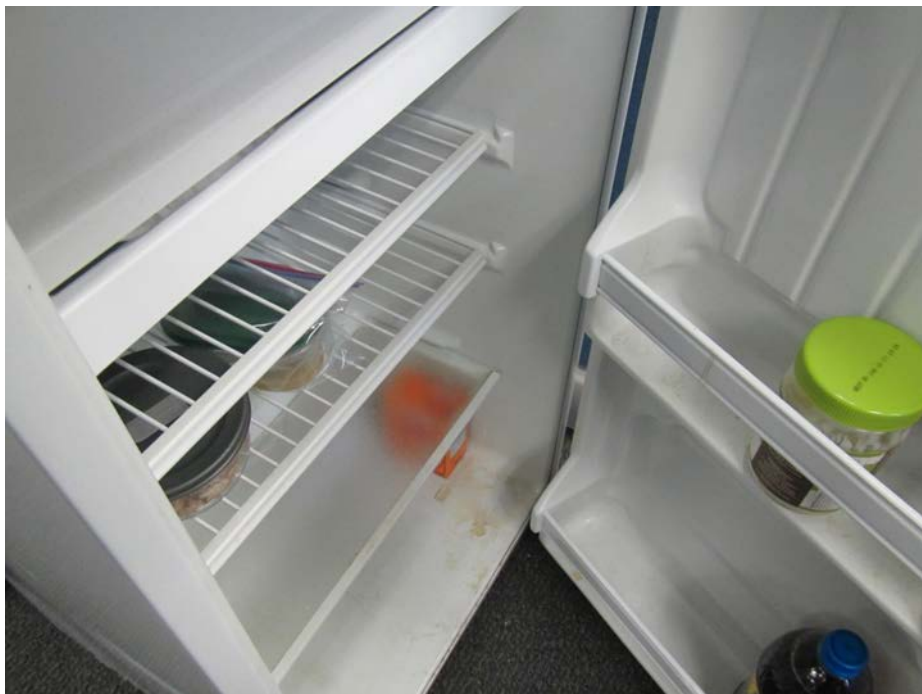
**Picture 8**

**Refrigerator with evidence of spill on bottom shelf**

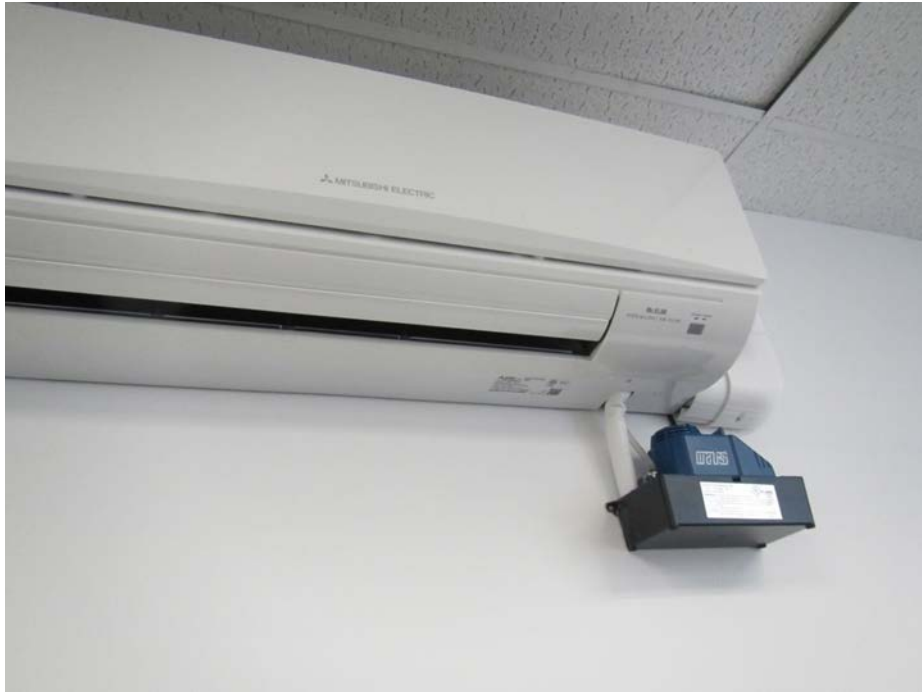
**Picture 9**

A ductless air conditioning unit was observed in the computer training room (Picture 9). The condensate pump and piping that connect this unit with a drain should be inspected periodically for clogs and leaks to prevent water damage to nearby building materials.

**Ductless air-conditioning unit in computer training room**

8. Inspect condensate pumps and piping for ductless air-conditioning units regularly.
9. Have the peeling paint on the ceiling beams repaired.

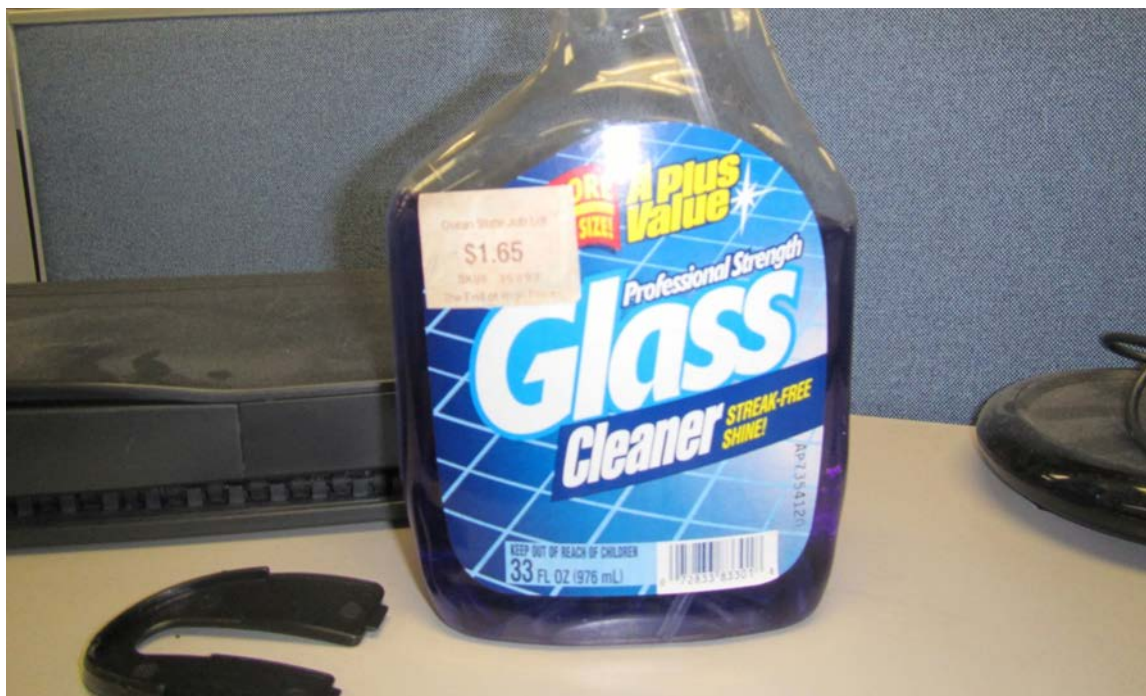
**Picture 10**

Exposure to low levels of total volatile organic compounds (TVOCs) may produce eye, nose, throat, and/or respiratory irritation in some sensitive individuals. To determine if VOCs were present, BEH/IAQ staff examined rooms for products containing VOCs. BEH/IAQ staff noted hand sanitizers, cleaners, scented candles, and dry erase materials in use within the building (Pictures 10 and 11; Table 1). All of these products have the potential to be irritants to the eyes, nose, throat, and respiratory system of sensitive individuals.

**Cleaning product in an office**

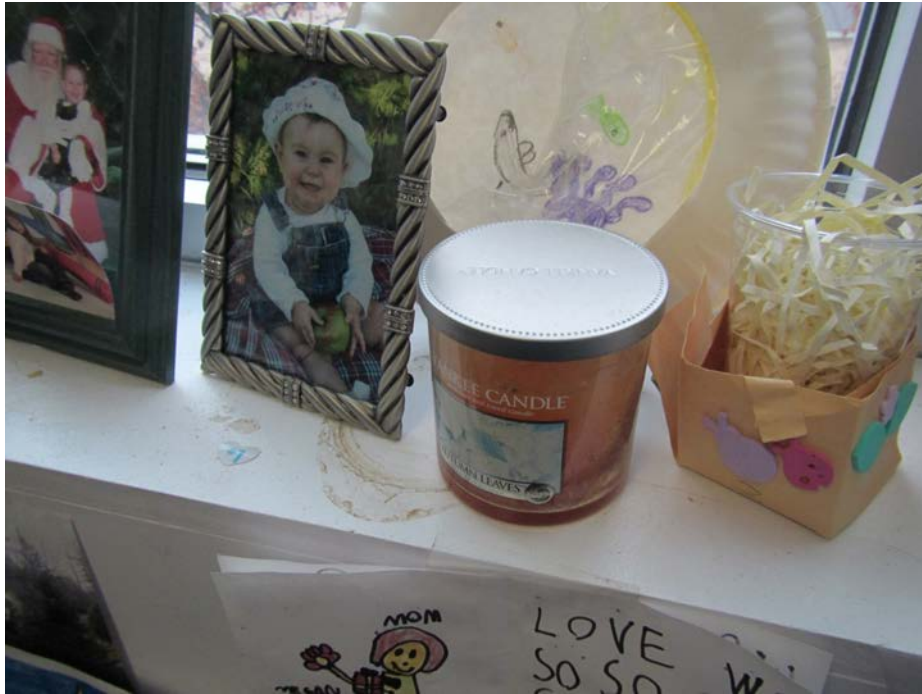
**Picture 11**

**Scented candle**

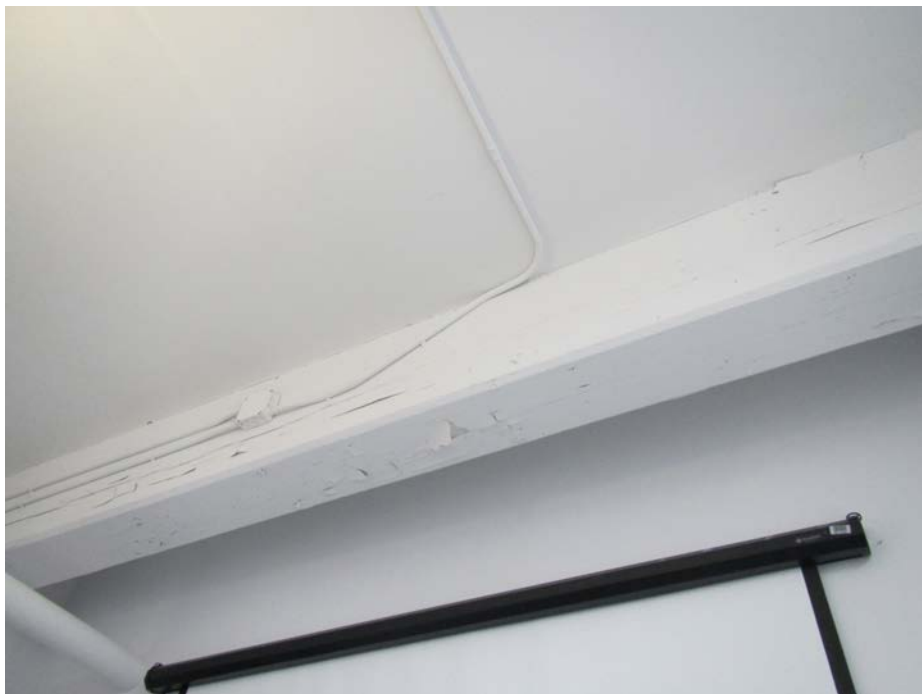
**Picture 12**

Peeling paint was observed on ceiling beams in a few areas (Picture 12). This can create irritating dust and it is unknown if the paint may contain lead.

**Peeling paint on a ceiling beam**

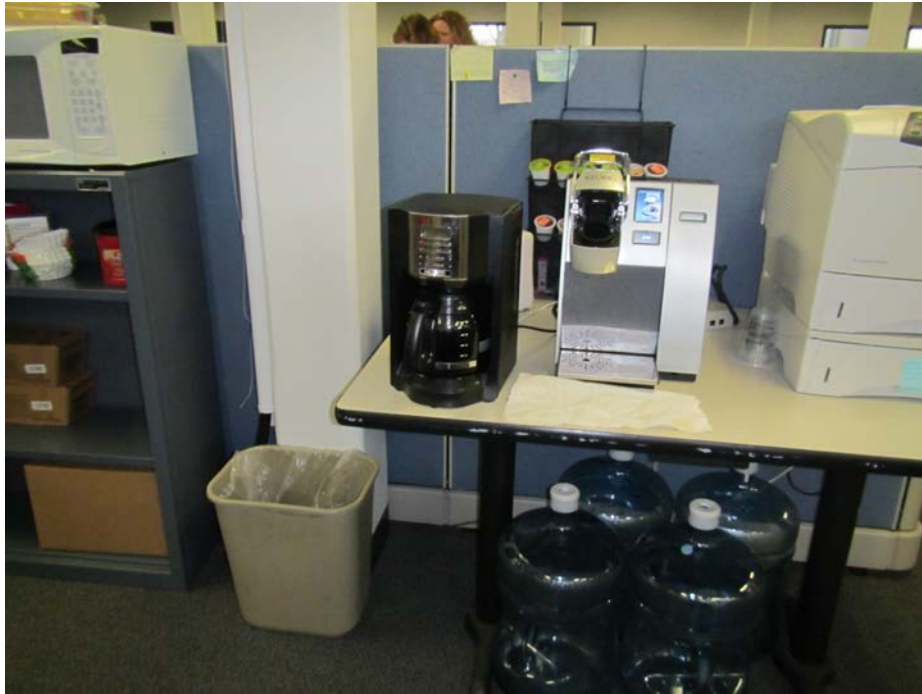
**Picture 13**

Cooking equipment, including toasters, microwave ovens and coffee machines were located in various parts of the office space (Picture 13). The presence of so many different pieces of cooking equipment near workstations and without direct exhaust ventilation increases the chance of food odors permeating office areas. Food areas and cooking equipment need to be kept clean to prevent odors and pests. Carpeting in these areas may trap crumbs and spills as well.

**Coffee station and microwave oven**

Consider consolidating cooking areas into unoccupied and uncarpeted areas or protect the carpeting in these areas with a mat.

10. Ensure cooking areas/equipment are kept clean to prevent odors and pests. Consider reducing the number of areas where food is stored and locating them away from occupied areas.
